"Full" Reserve Study

Makaha Surfside AOA Waianae, HI

Report #: 32902-0
For Period Beginning: January 1, 2018
Expires: December 31, 2018

Date Prepared: May 9, 2018

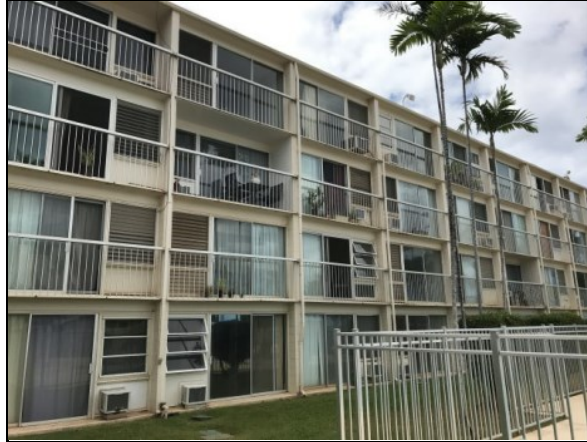
Useful Life:
30 years

Remaining Life:
29 years

Best Case: \$ 643,000

Worst Case: \$ 663,000

| # Component | Quantity | Useful Life | Rem. Useful Life | Current Cost Estimate | |
|---|---|---|---|---|---|
| 105 Decking - Replace/Rebuild (Ph 1) | ~ 1/3 of 40,200 GSF | 30 | 29 | \$643,000 | \$663,000 |

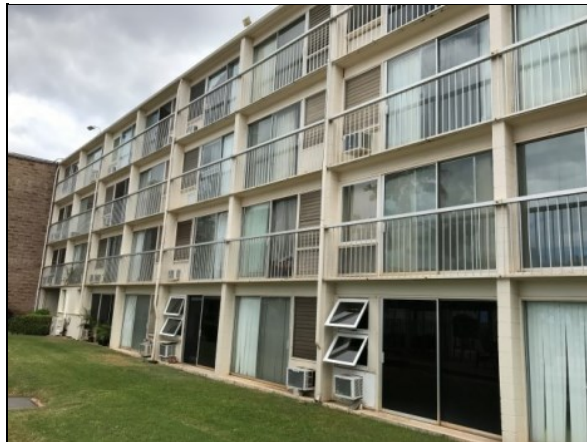
Useful Life:
30 years

Remaining Life:
1 years

Best Case: \$ 450,000

Worst Case: \$ 550,000

| # Component | Quantity | Useful Life | Rem. Useful Life | Current Cost Estimate | |
|---|---|---|---|---|---|
| 105 Decking - Replace/Rebuild (Ph 2) | ~ 1/3 of 40,200 GSF | 30 | 1 | \$450,000 | \$550,000 |

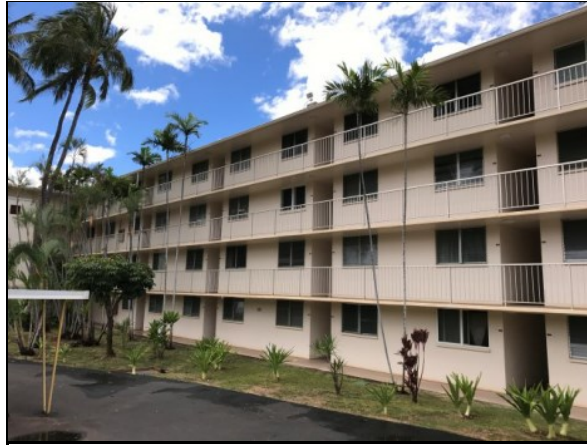
Useful Life:
30 years

Remaining Life:
2 years

Best Case: \$ 450,000

Worst Case: \$ 550,000

| # Component | Quantity | Useful Life | Rem. Useful Life | Current Cost Estimate | |
|---|---|---|---|---|---|
| 105 Decking - Replace/Rebuild (Ph 3) | ~ 1/3 of 40,200 GSF | 30 | 2 | \$450,000 | \$550,000 |

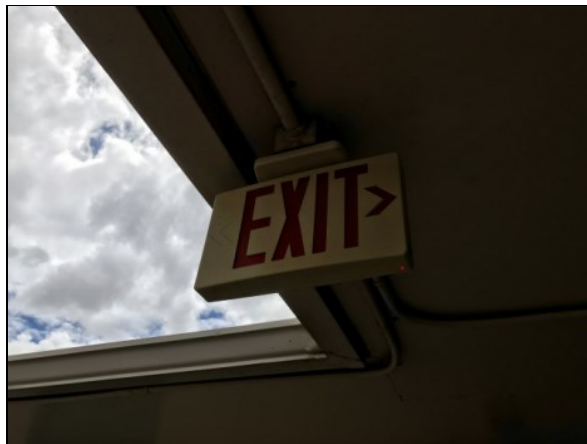
Useful Life:
20 years

Remaining Life:
15 years

Best Case: \$ 17,600

Worst Case: \$ 22,000

| # Component | Quantity | Useful Life | Rem. Useful Life | Current Cost Estimate | |
|---|---|---|---|---|---|
| 326 Emergency/Exit Lights - Replace | ~ (81) EXIT; (7) Emerg. | 20 | 15 | \$17,600 | \$22,000 |

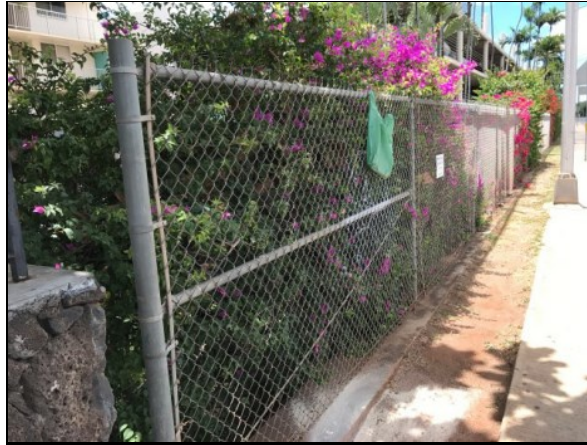
Useful Life:
30 years

Remaining Life:
0 years

Best Case: \$ 168,000

Worst Case: \$ 188,000

| # Component | Quantity | Useful Life | Rem. Useful Life | Current Cost Estimate | |
|---|---|---|---|---|---|
| 502 Chain Fence/Beach Gates - Replace | ~ 2,385 LF | 30 | 0 | \$168,000 | \$188,000 |

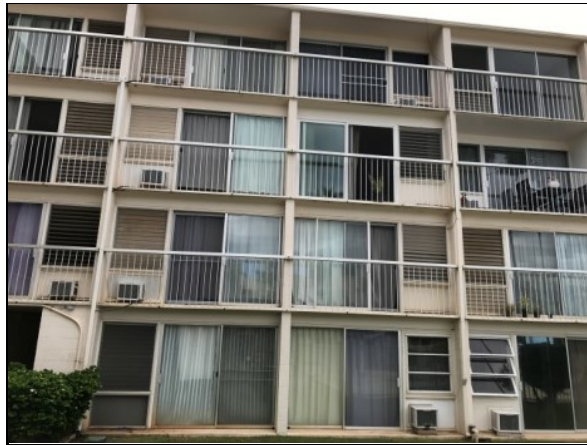
Useful Life:
25 years

Remaining Life:
5 years

Best Case: \$ 346,000

Worst Case: \$ 432,000

| # Component | Quantity | Useful Life | Rem. Useful Life | Current Cost Estimate | |
|---|---|---|---|---|---|
| 503 Metal Rails - Replace | ~ 8,640 LF | 25 | 5 | \$346,000 | \$432,000 |

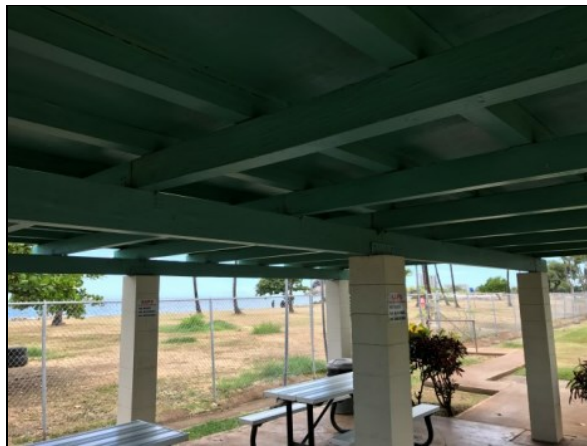
Useful Life:
25 years

Remaining Life:
10 years

Best Case: \$ 32,000

Worst Case: \$ 40,000

| # Component | Quantity | Useful Life | Rem. Useful Life | Current Cost Estimate | |
|---|---|---|---|---|---|
| 509 Wood Pergolas - Replace | (1) 20 X 11; (1) 26 X 23 | 25 | 10 | \$32,000 | \$40,000 |

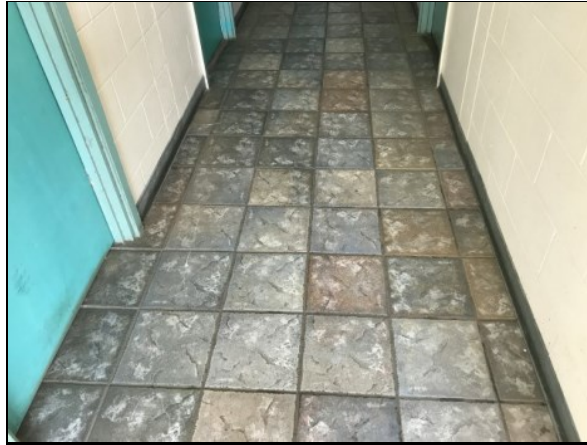
Useful Life:
25 years

Remaining Life:
3 years

Best Case: \$ 73,500

Worst Case: \$ 88,200

| # Component | Quantity | Useful Life | Rem. Useful Life | Current Cost Estimate | |
|---|---|---|---|---|---|
| 603 Tile Floor - Replace | ~ 4,900 GSF | 25 | 3 | \$73,500 | \$88,200 |

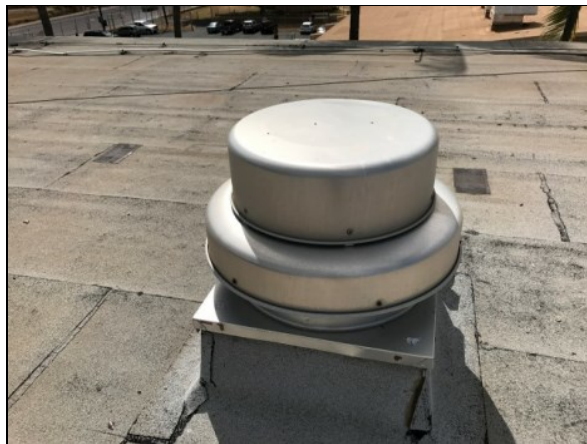
Comp #: 306 Vent Fans - Replace

Evaluation: Reported replacement is anticipated immediately.

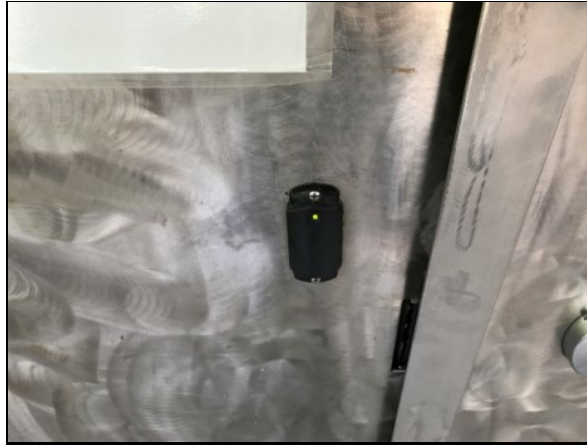
Comp #: 709 FOB Entry System - Replace

Evaluation: No damage or non-function visible. No reports of any function issues since installation. Exact cost unknown at this time. Plan for full service life at this time.

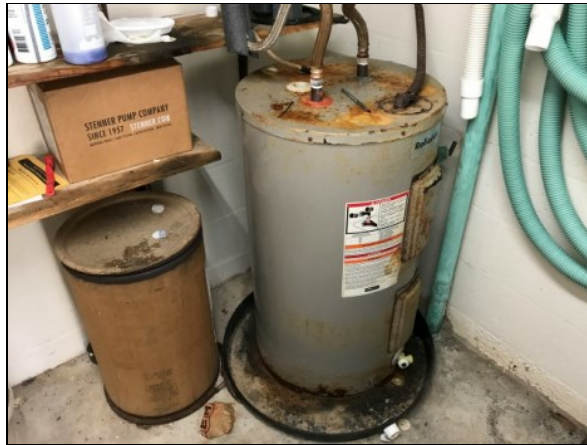
Comp #: 803 Water Heater - Replace

Evaluation: Heavy exterior damage visible. This an old unit that should be anticipated for replacement immediately. Due to the low cost of replacement, plan to complete via Operating Funds.

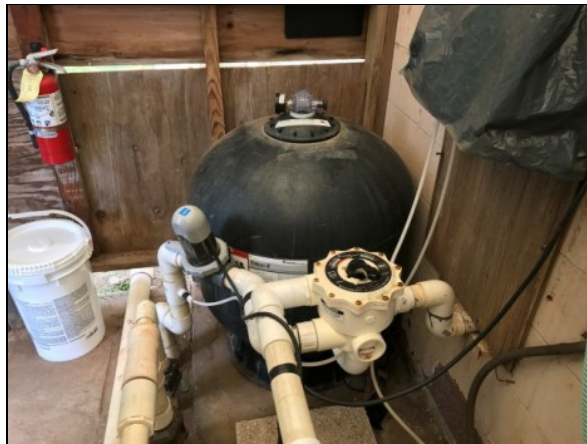
Comp #: 1207 Pool Filters - Replace

Evaluation: No atypical damage or wear conditions visible. No reports of any function issues. Plan for full service life.

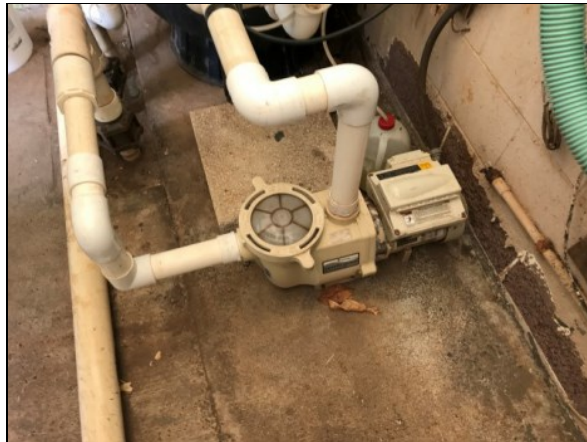
Comp #: 1210 Pool Pumps - Replace

Evaluation: No atypical damage or wear. Funding for the replacement of the pump assembly and motors. Replace individual motors as needed as an Operating expense.

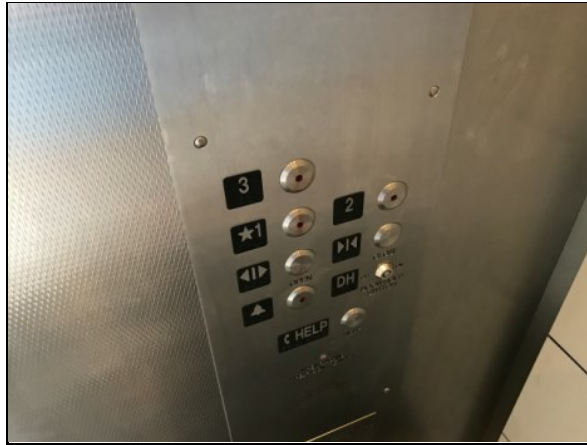
Evaluation: We are not licensed to inspect these systems. Not tested during inspection, but found to be operational. Anticipate the need to modernize a hydraulic elevator every 20-30 years. Modernization consists primarily of replacing the controller, door operator, pumping unit, valve, tank, push-button fixtures & indicator fixtures.

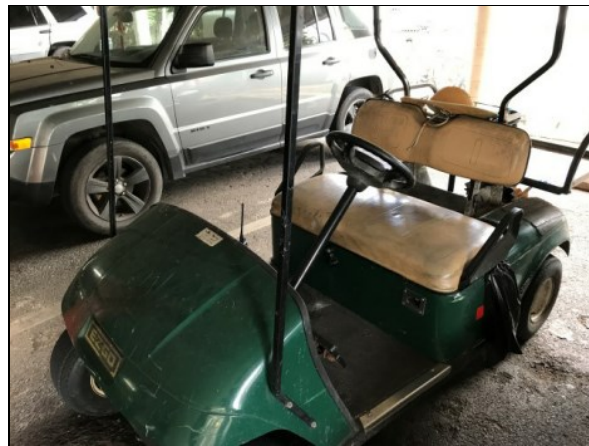
Comp #: 1810 Utility Vehicles - Replace

Evaluation: These units are showing signs of heavy wear and exterior damage. Replacement should be anticipated.

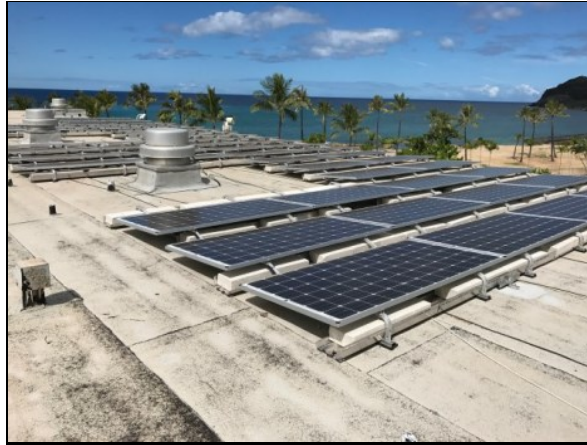
Comp #: 1905 Solar System - Replace

Evaluation: According to the community's contract, there was no cost to install the system and long term maintenance/repair is not the responsibility of the Association.

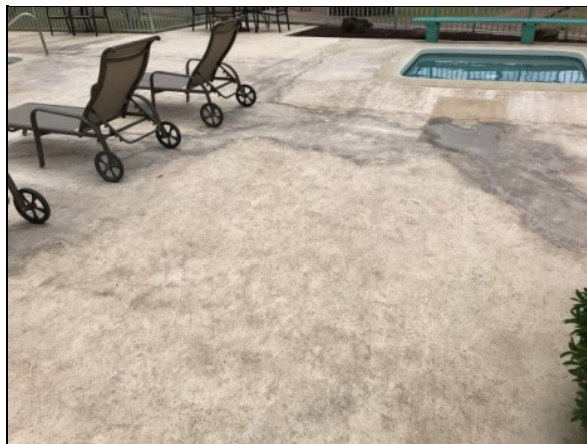
Comp #: 1200 Pool Decks - Replace

Evaluation: Stable conditions notable with no large-scale cracking or trip hazards apparent. At this time, there is no anticipation of total replacement needs, if cleaned and sealed on a consistent basis. Plan for local repair needs using general Operating Funds.

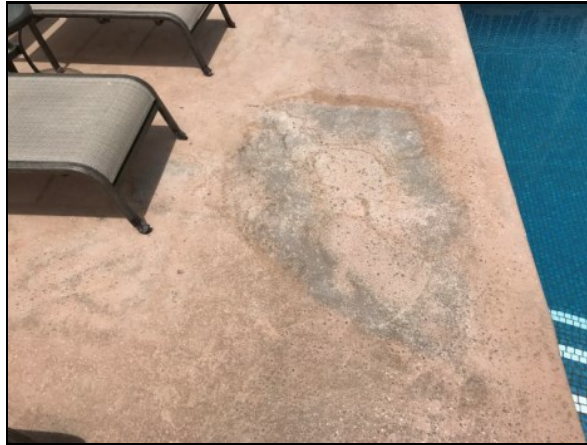
Evaluation: Generally poor surface conditions notable with staining, discoloration and heavy surface wear apparent at higher traffic areas. Anticipate Seal efforts in the near future to mitigate further damage.

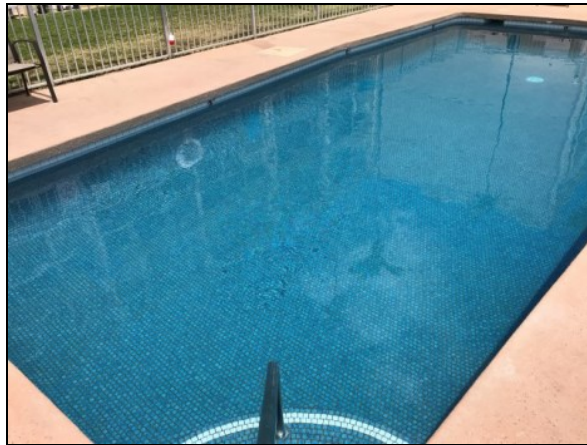
Evaluation: No major damage or wear notable at the time of inspection. Some normal discoloration but largely intact and functional. Plan for larger projects around the 15-year mark of life.

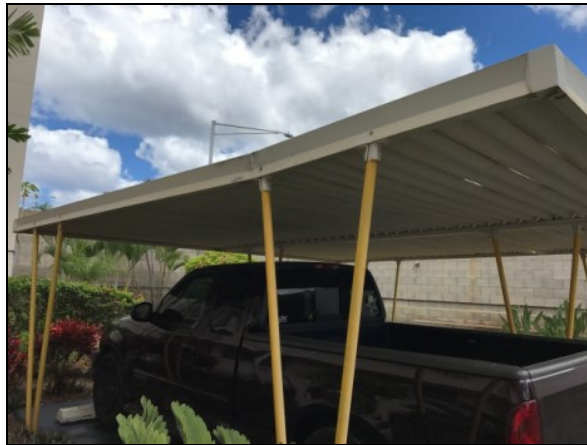
Comp #: 520 Carport Structures - Replace

Evaluation: Generally stable conditions apparent. No visible large-scale corrosion or damage. With normal Painting there is no anticipation of major impact to Reserves. Plan to repair via Operating Funds as-needed.

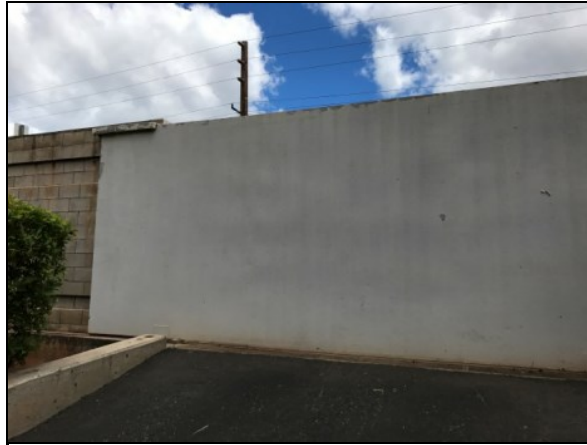
Comp #: 708 Entry Gate - Replace

Evaluation: It appears this fixture is currently not in use as a access gate. At this time, we will not factor for cyclical replacement.

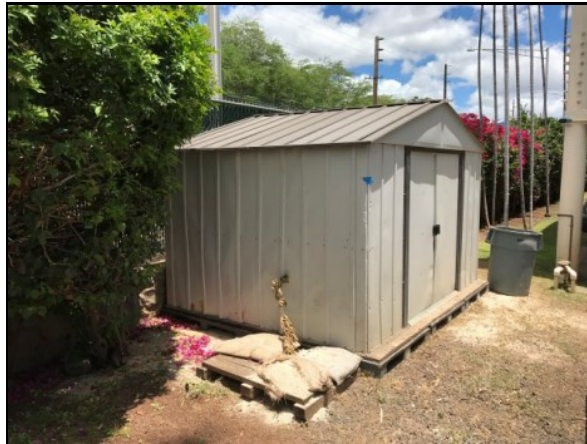
Comp #: 725 Storage Shed - Replace

Evaluation: Noted to be showing general age and wear at the time of inspection. Corrosion, denting and discoloration apparent. Plan for periodic replacement on roughly the schedule below.

Useful Life:
15 years

Remaining Life:
2 years

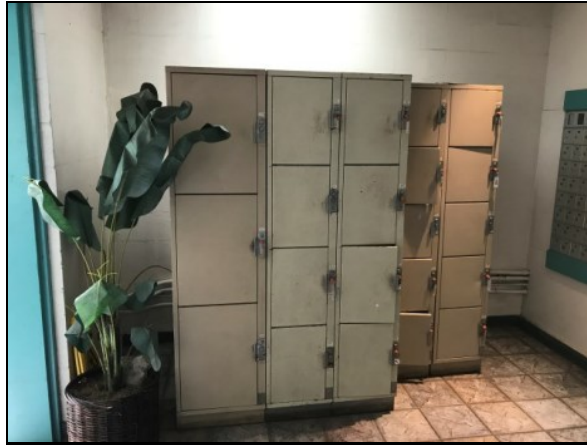
Comp #: 913 Lockers - Replace

Evaluation: Generally aged and worn fixtures notable. The community should anticipate replacement in the near future.

Useful Life:
15 years

Remaining Life:
0 years

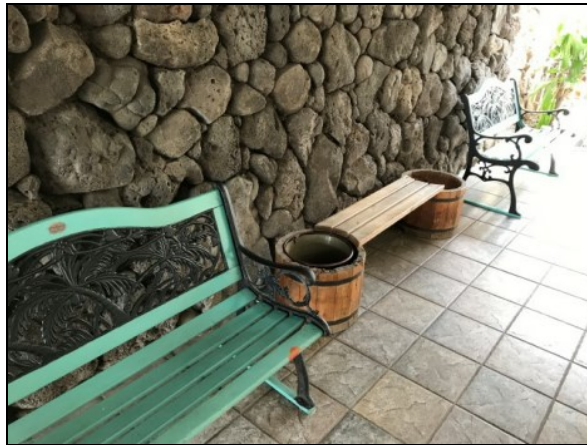
Comp #: 915 Benches - Replace

Evaluation: Assorted styles and conditions notable. At this time, we anticipate local replacement projects to be executed using general Operating Funds. Plan to update this component in future years if a pattern of widespread replacement becomes apparent.

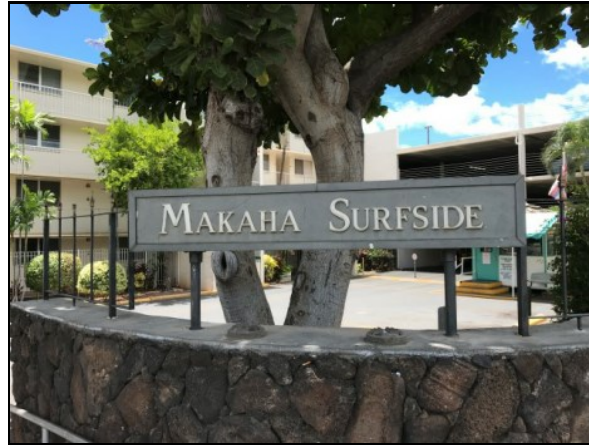
Comp #: 1402 Entry Sign - Replace

Evaluation: Stable but aged appearance notable. The community should anticipate periodic replacement to maintain a quality aesthetic.

Useful Life:
15 years

Remaining Life:
0 years
